Update "With-Site-Visit" Reserve Study

Green Valley Ranch - North Sub District #1 Denver, CO

Report #: 35889-1
For Period Beginning: January 1, 2021
Expires: December 31, 2021

Date Prepared: December 2, 2020

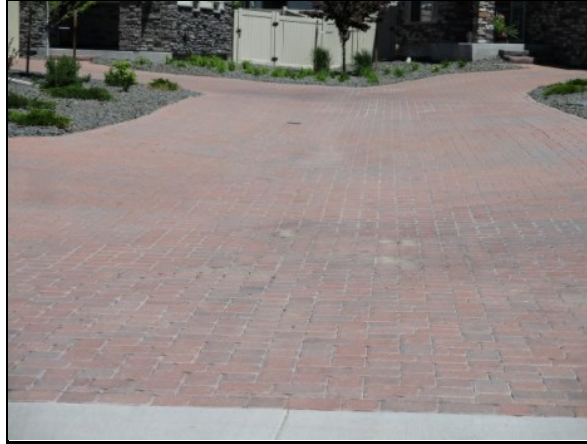
Useful Life:
5 years

Remaining Life:
0 years

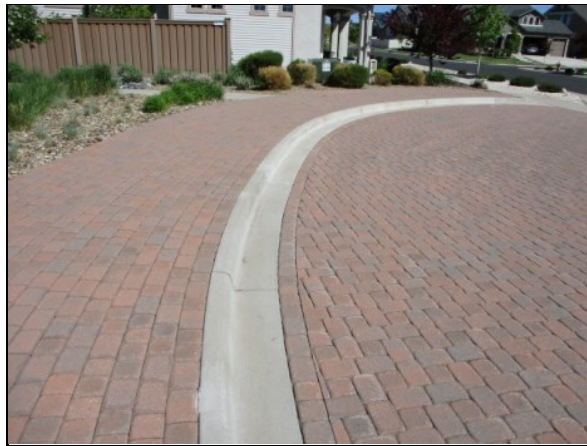
Comp #: 2121 Snowmelt Paver Drive - Replace

Useful Life:
30 years

Remaining Life:
21 years

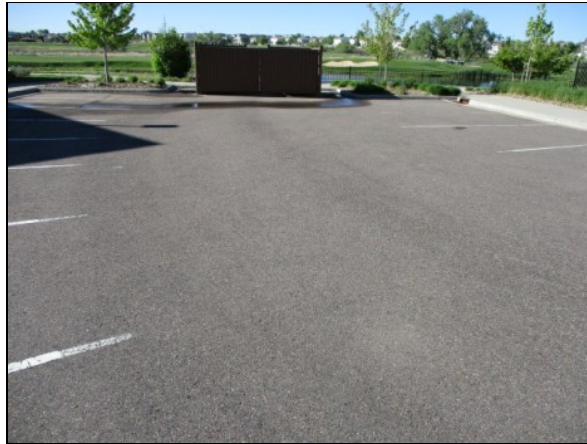
Remaining Life:

0 years
