Update "With-Site-Visit" Reserve Study

Green Valley Ranch - North Sub District #1 Denver, CO

Report #: 35889-1
For Period Beginning: January 1, 2021
Expires: December 31, 2021

Date Prepared: December 2, 2020

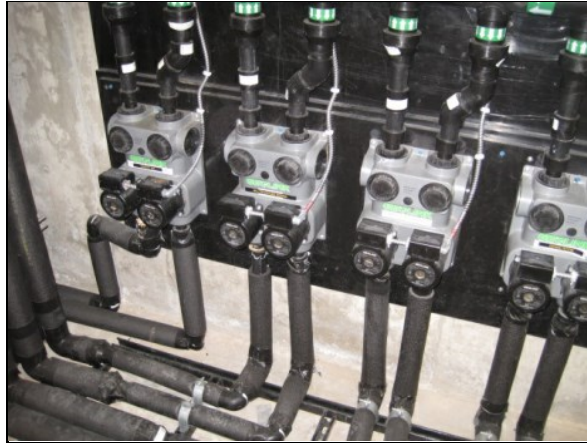
Comp #: 2535 Distribution Manifold - Replace

Comments: Minimal or no subjective/aesthetic value for this component. Useful life is based primarily on normal expectations for service/performance life in this location. Unless otherwise noted remaining useful life expectancy is based primarily on original installation or last replacement/purchase date our experience with similar systems/components and assuming normal amount of usage and good preventive maintenance. No access to see pumps closely. Costs based on input from building/management staff and/or experience with similar installations. Sump pump systems can have a highly variable life expectancy depending on level of use. Should be inspected regularly and repaired as-needed by servicing vendor or maintenance staff to ensure proper function and optimal performance.

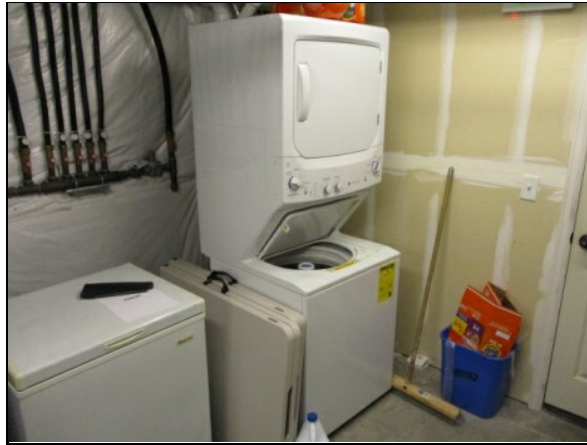
Comp #: 2541 Laundry Machines - Replace

Comments: Minimal or no subjective/aesthetic value for this component. Useful life is based primarily on normal expectations for service/performance life in this location. Unless otherwise noted remaining useful life expectancy is based primarily on original installation or last replacement/purchase date our experience with similar systems/components and assuming normal amount of usage and good preventive maintenance. Laundry machines should be inspected serviced and repaired as needed by vendor and/or staff to ensure full useful life and achieve optimal performance. Useful life expectancy shown here assumes proper preventive maintenance and normal levels of use. Costs to replace are based on replacement with same-size units unless otherwise noted.

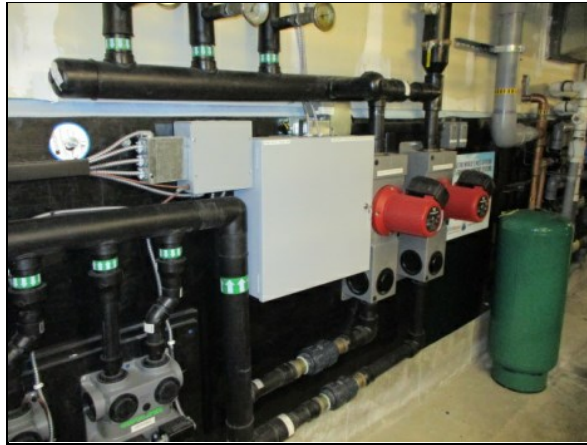
Comp #: 2545 BAS Equipment - Replace

Comments: Minimal or no subjective/aesthetic value for this component. Useful life is based primarily on normal expectations for service/performance life in this location. Unless otherwise noted remaining useful life expectancy is based primarily on original installation or last replacement/purchase date our experience with similar systems/components and assuming normal amount of usage and good preventive maintenance. Computers and other IT equipment have a relatively short useful life (depending on the application and level of use) due to advancements in technology. Plan to replace/upgrade the existing equipment at the approximate interval shown here to ensure proper function and uninterrupted service. Keep track of any partial replacements and include cost history during future Reserve Study updates.

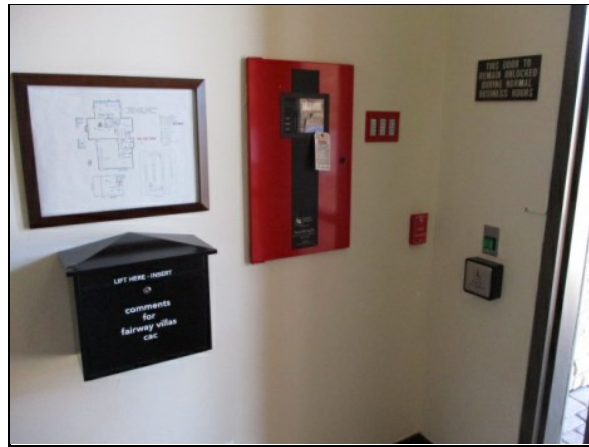
Comp #: 2553 Fire Control Panel - Update/Replace

Comments: Our inspection is for planning and budgeting purposes only fire alarm equipment is assumed to have been designed and installed properly and is assumed to comply with all relevant building codes. Regular testing and inspections should be conducted as an Operating expense. In many cases manufacturers discontinue support of equipment after a certain number of years which may limit availability of replacement parts as the system ages. Cost estimates assume that existing wiring can be re-used and that only panel and devices will be replaced. If wiring requires replacement estimates should be increased accordingly but in our experience wiring should have an indefinite useful life. Cost estimates are based on quantity and type of existing equipment not including any expansion or upgrades which may be required. We recommend reviewing system components with fire alarm vendor on a regular basis. If expansion of system is found to be required the Reserve Study should be updated and any additional costs should be factored accordingly.

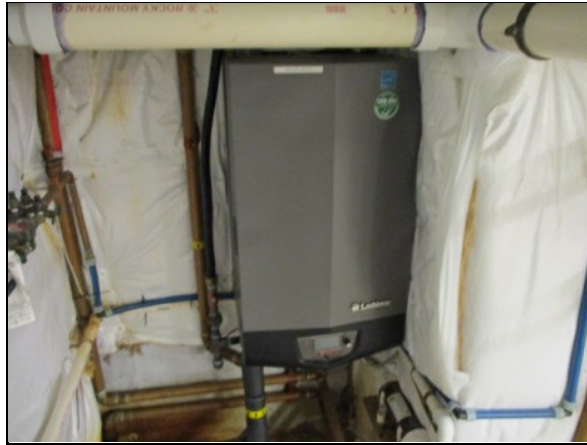
Comp #: 2561 Tankless Boiler - Replace

Comments: Lochnivar knight model 285K BTU electric boiler. Minimal or no subjective/aesthetic value for this component. Useful life is based primarily on normal expectations for service/performance life in this location. Unless otherwise noted remaining useful life expectancy is based primarily on original installation or last replacement/purchase date our experience with similar systems/components and assuming normal amount of usage and good preventive maintenance. With routine inspection and maintenance the boiler should have an approximate useful life as shown below before replacement with future technology and efficiencies will be warranted. Life expectancy can vary based on level of use and location on the property. When considering replacements the client should strongly consider replacing with high-efficiency models. Although initial cost may be higher than conventional alternatives the payback period in energy savings is often a fraction of the overall life span of the boiler itself. Costs to replace are based on replacement with same approximate size and capacity.

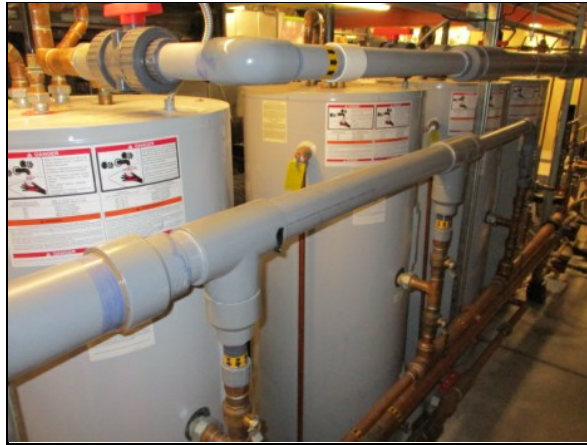
Comp #: 2563 Water Heater/Tank - Replace

Comments: State 119 gallon solar water heater model SGV1201OTS serial number 1152M001230 1201M000252 1152M001232 1201M000271. Minimal or no subjective/aesthetic value for this component. Useful life is based primarily on normal expectations for service/performance life in this location. Unless otherwise noted remaining useful life expectancy is based primarily on original installation or last replacement/purchase date our experience with similar systems/components and assuming normal amount of usage and good preventive maintenance. Water heater life expectancies can vary greatly depending on level of use type of technology amount of preventive maintenance and other factors. Should be inspected and repaired as needed by servicing vendor or maintenance staff. Unless otherwise noted expected to be functional. Plan to replace at the approximate interval shown below. When evaluating replacements we recommend choosing high-efficiency or tankless models if possible in order to minimize energy usage.

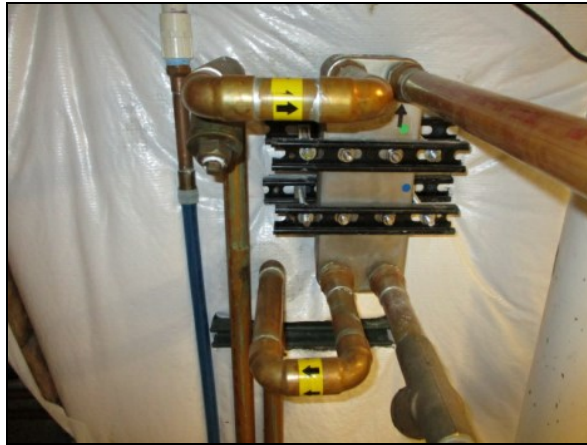
Comp #: 2567 Heat Exchangers - Replace

Comments: Maxi-Flo model MF 260 heat exchanger. Minimal or no subjective/aesthetic value for this component. Useful life is based primarily on normal expectations for service/performance life in this location. Unless otherwise noted remaining useful life expectancy is based primarily on original installation or last replacement/purchase date our experience with similar systems/components and assuming normal amount of usage and good preventive maintenance. Heat exchanger should be inspected and serviced regularly as an Operating expense. In some cases individual parts (i.e. plates for plate heat exchanger units) can be replaced without needing to replace the entire unit. Costs shown here are based on complete replacement unless otherwise noted.

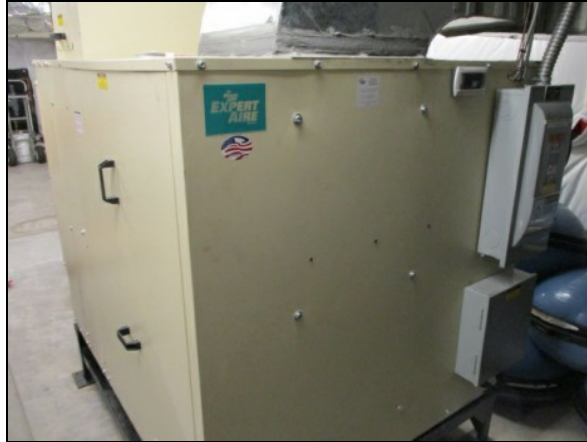
Comp #: 2849 Dehumidifier - Replace

Comments: Desert Aire - Expert Aire series model LC08N6QBETDLCED serial number 1213D21793. Minimal or no subjective/aesthetic value for this component. Useful life is based primarily on normal expectations for service/performance life in this location. Unless otherwise noted remaining useful life expectancy is based primarily on original installation or last replacement/purchase date our experience with similar systems/components and assuming normal amount of usage and good preventive maintenance. We recommend that routine repairs and maintenance such as filter replacements system flushing etc. be budgeted as an Operating expense. Useful life can often be extended with proactive service and maintenance. Unless otherwise noted funding for system with same size/capacity as the current system. For split systems we recommend budgeting to replace the entire system (condensing unit and air handler) together in order to obtain better unit pricing and ensure maximum efficiency refrigerant compatibility etc. If additional costs are expected during replacement such as for system reconfiguration or expansion ductwork repairs electrical work etc. costs should be re-evaluated and adjusted as needed during future Reserve Study updates.

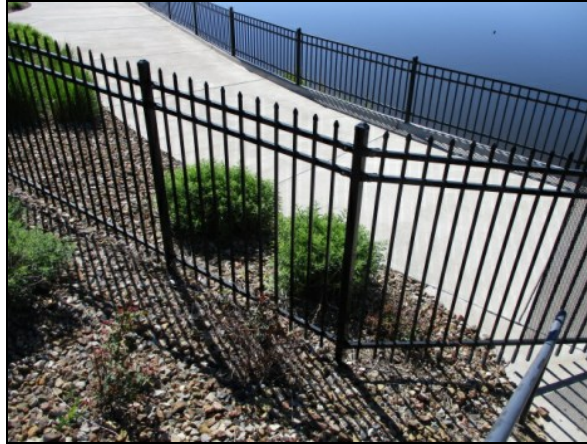
Comp #: 2805 Fencing: Metal - Replace

Comments: Metal railing determined to be in fair condition typically exhibits some minor to moderate amounts of surface wear and other signs of age which may include corrosion loose or unstable pieces/sections or hardware and/or overgrowth by surrounding vegetation. Overall appears to be in serviceable but declining condition. In our experience metal railing will typically eventually break down due to a combination of sun and weather exposure which is sometimes exacerbated by other factors such as irrigation overspray abuse and lack of preventive maintenance. For some types of fencing complete replacement is advisable over recoating or refinishing due to relatively short lifespan of coatings and consideration of total life-cycle cost.
